NREL Small Wind Turbine Test Project: Mariah Power's Windspire Wind Turbine Test Chronology

Technical Report NREL/TP-500-45552 June 2009

Mariah Power's Windspire Wind Turbine Test Chronology

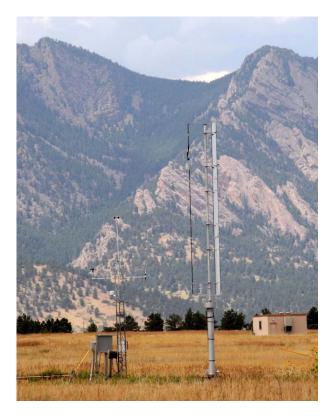
Mariah Power's 1.2-kW vertical-axis Windspire Giromill wind turbine installed for testing at the NWTC.

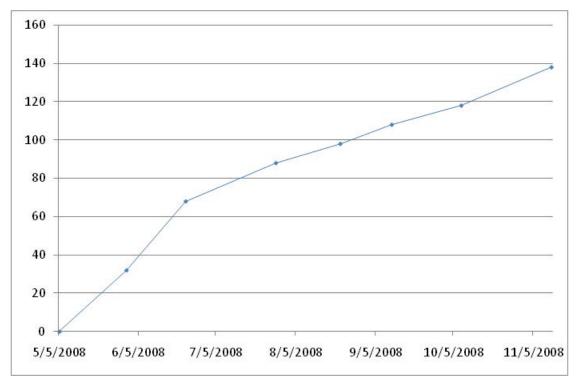
Windspire Cumulative Power Production from May through November 2008

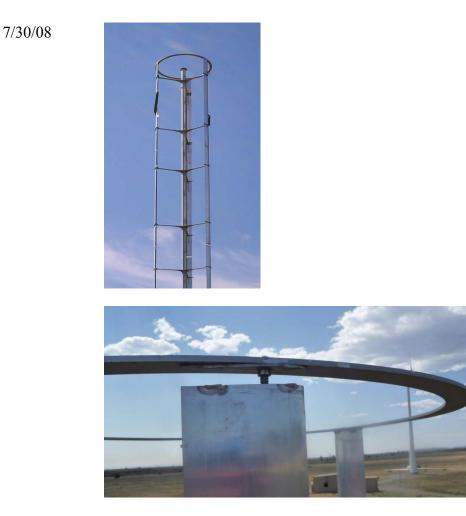
While the leading edge tape was being replaced (due to detachment), a broken weld was found at the top of the turbine and another crack was observed on a different weld. Initially, the welding was done in two spots per airfoil side. The airfoils also slid out of the struts that are supposed to clamp them. This may have caused the broken weld. The turbine was visibly wobbling and was tilted down.

- 8/7/08 The manufacturer was on-site to replace the airfoils and struts. This is a change that will be required for all production machines. The tower base bolts were replaced with bolts with set screws to keep bolts from loosening. The weld was improved to a continuous weld.
- 8/18/08 The magnetic bearing was replaced. The initial magnetic bearings did not have a dust cover and were susceptible to iron dust getting into the magnetic air gap, which can stop operation of the turbine.

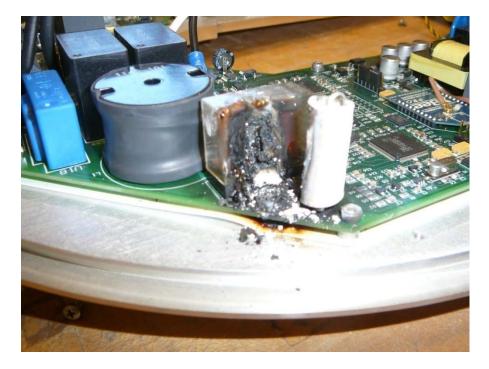
9/13/08

The inverter failure occurred because the set points of the inverter were set to optimize power performance. The increased performance caused the temperature to rise, and over time, caused the inverter to fail. The inverter was replaced. The set points were set for normal production.

- 10/7/08 The power performance test was stopped because the inverter failed. The test was not completed because the wind speed range requirement was not fulfilled/met. A new power performance test was started after the inverter was replaced.
- 10/14/08 Mariah informed us that: "the welding of the top shaft has not been stress relieved properly and has a heat affected zone that has reduced strength and fatigue life below the design." Based on the findings from an accelerated life test conducted at the Mariah facility, Mariah requested that the testing team stop and/or lower the turbine in winds above 40 mph until a fix could be implemented, The fix is not expected until January 2009.

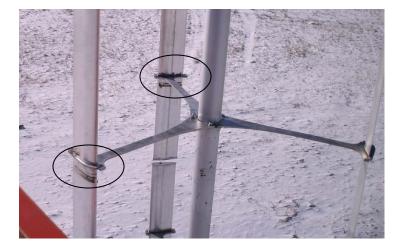
11/19/08

Two out of three airfoils slid down through the struts. In the picture, the black markings show where the airfoils used to be.

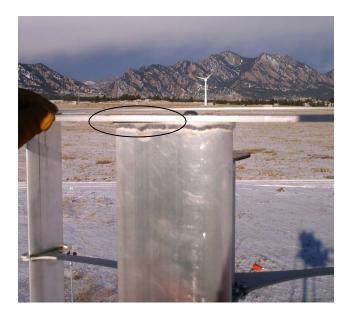
During the noise testing, a clanging sound emanated from the turbine. The testing team found two broken welds at the top of the turbine. The turbine was shut down until further notice. This photo shows one of the broken welds that caused the airfoil to separate from its end plate. However, the airfoil did not completely separate as it did in the previous occurrence.

- New air foils replace welded end plates. These end plates are now secured with stainless steel M8 fasteners.
- The safety rings are now segmented and attached with mechanical fasteners. These replaced the butt welded rings.
- The airfoil clamping system was redesigned which provides for a more concentric gripping force. These new opposing clamps secure the airfoils from slippage.
- We have engineered stiffer and straighter shafts, and added ¼ inch thickness to the base plate. These help improve longevity and address early modal/resonance disturbances.
- The loose nuts encountered on this test unit were not encountered on any of the other field units. We believe this issue arose on the test unit due to undue stress from poor shaft straightness (see above).
- A new clamping method was developed to secure the top shaft and generator in order to eliminate fretting.
